DEPARTMENT OF TRANSPORTATION**DIVISION OF ENGINEERING SERVICES**

Contract #: 04-0120F4Cty: SF/ALA Rte: 80 PM: 13.2/13.9File #: 69.28**WELDING INSPECTION REPORT****Resident Engineer:**Siegenthaler, Peter**Address:** 333 Burma Road**City:** Oakland, CA 94607**Report No:** WIR-018741**Date Inspected:** 20-Dec-2010**Project Name:** SAS Superstructure**OSM Arrival Time:** 700**Prime Contractor:** American Bridge/Fluor Enterprises, a JV**OSM Departure Time:** 1900**Contractor:** Zhenhua Port Machinery Company, Ltd (ZPMC), Changxing Island **Location:** Shanghai, China**CWI Name:** Mr.Zhu Zhong Hai.**CWI Present:** Yes No**Inspected CWI report:** Yes No N/A**Rod Oven in Use:** Yes No N/A**Electrode to specification:** Yes No N/A**Weld Procedures Followed:** Yes No N/A**Qualified Welders:** Yes No N/A**Verified Joint Fit-up:** Yes No N/A**Approved Drawings:** Yes No N/A**Approved WPS:** Yes No N/A**Delayed / Cancelled:** Yes No N/A**Bridge No:** 34-0006**Component:** Orthotropic Box Girder (OBG)**Summary of Items Observed:**

OBG TRAL ASSEMBLY

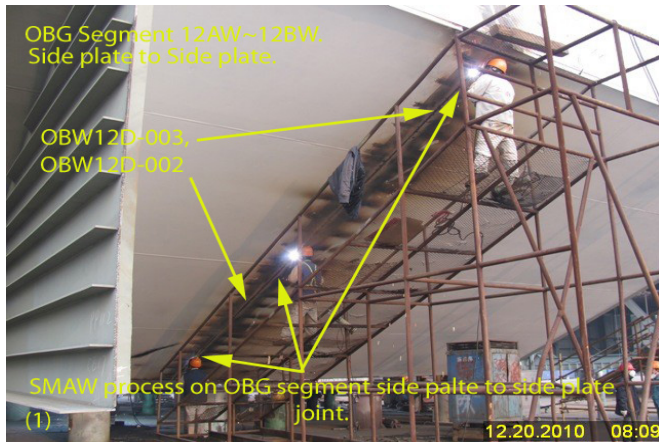
This QA Inspector observed ZPMC qualified welding personnel identified as 046709 Perform Shielded Metal Arc Welding (SMAW) on OBG segment 12AW +12BW Side plate to Side plate joint Cross beam side. Joint identified as OBW12D-003. ZPMC CWI Identified as Zhu Zhong Hai. The welding parameters as measured using QC's calibrated instrument appeared to be in general compliance with WPS-B-P-2214-B-U2-FCM-1. For more information see below attached picture number 1.

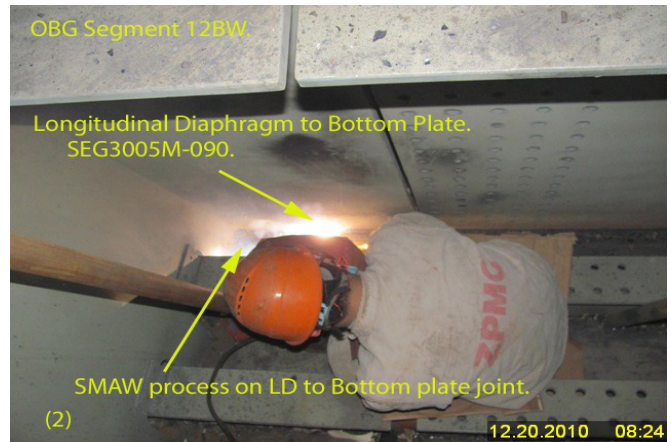
This QA Inspector observed ZPMC qualified welding personnel identified as 046704 Perform Shielded Metal Arc Welding (SMAW) on OBG segment 12BW Longitudinal Diaphragm to Bottom plate joint. Joint identified as SEG3005M-090. ZPMC QC Identified as Shi Lei. The welding parameters as measured using QC's calibrated instrument appeared to be in general compliance with WPS-B-P-2212-Tc-U4b-FCM-1. For more information see below attached picture number 2.
